■ ■ ■ ■ ■ ■ ■ SEDIMENT INTERIM
REMEDIAL
MEASURES REPORT
Pawtuxet River

July 31, 1996

CIBA-GEIGY Corporation
Route 37 West
Toms River, New Jersey 08754

Woodward-Clyde

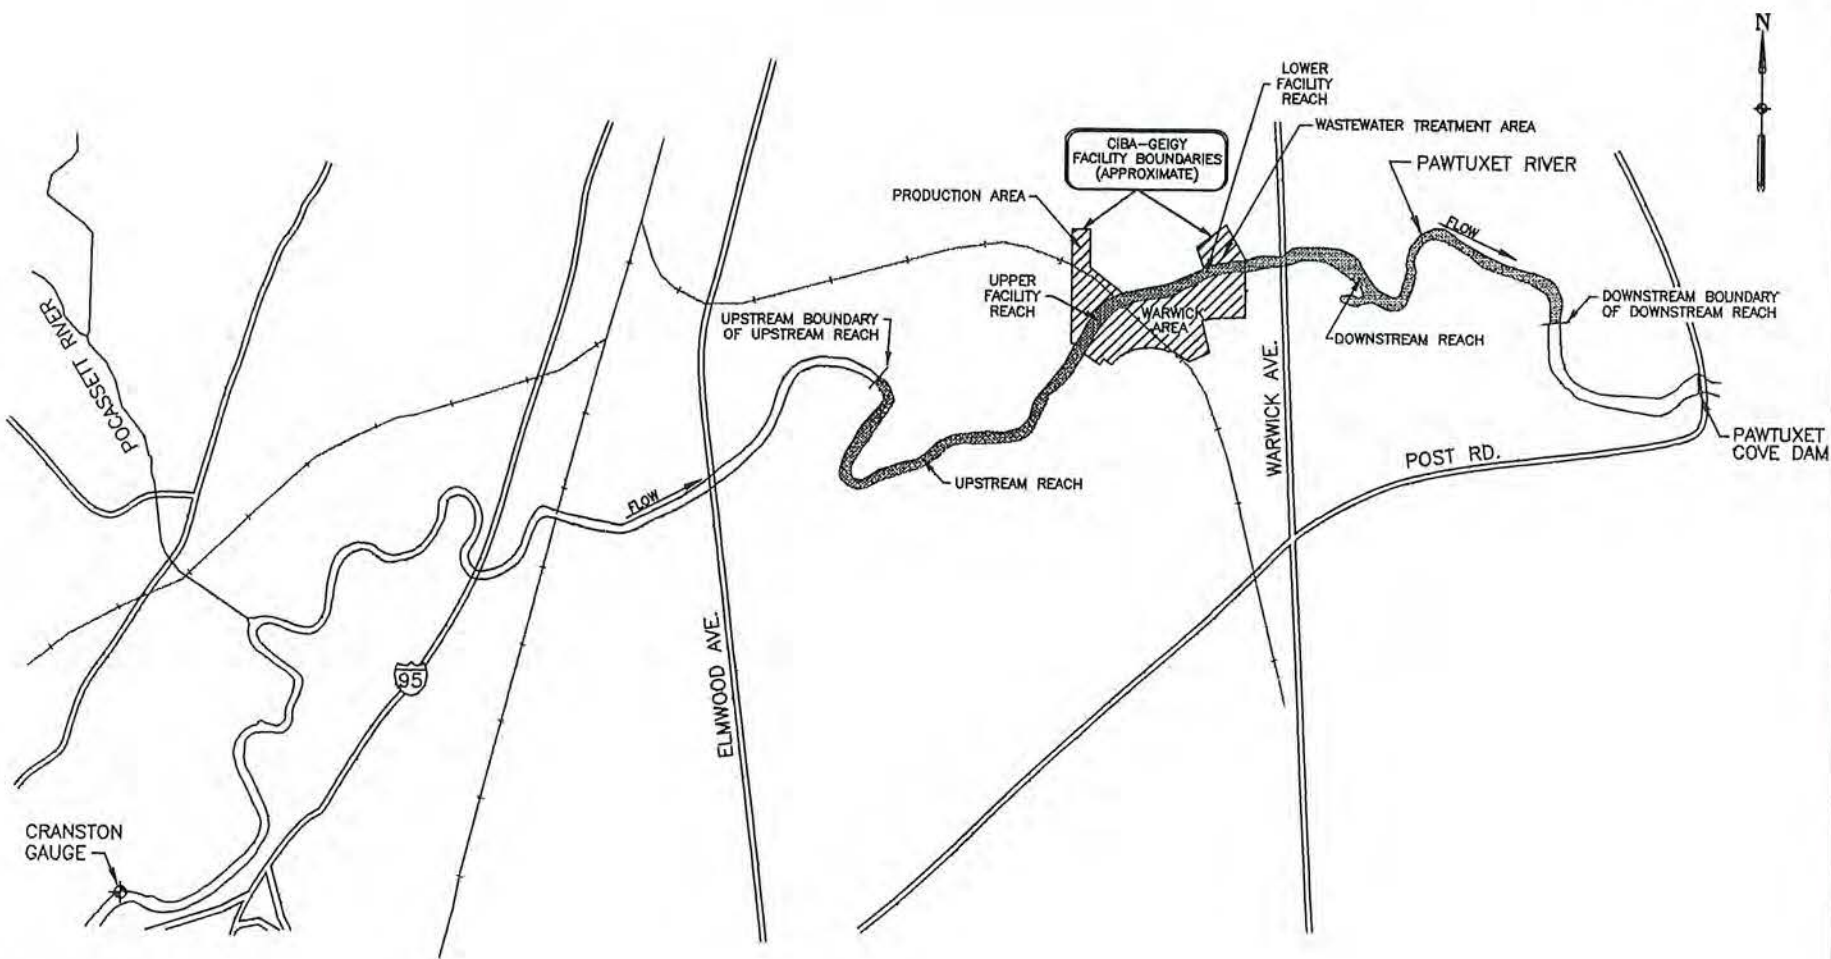
FIGURE 1-1

THE PAWTUXET RIVER REACHS:
UPSTREAM, FACILITY, AND DOWNSTREAM
COFFERDAM IRM
CRANSTON, RHODE ISLAND

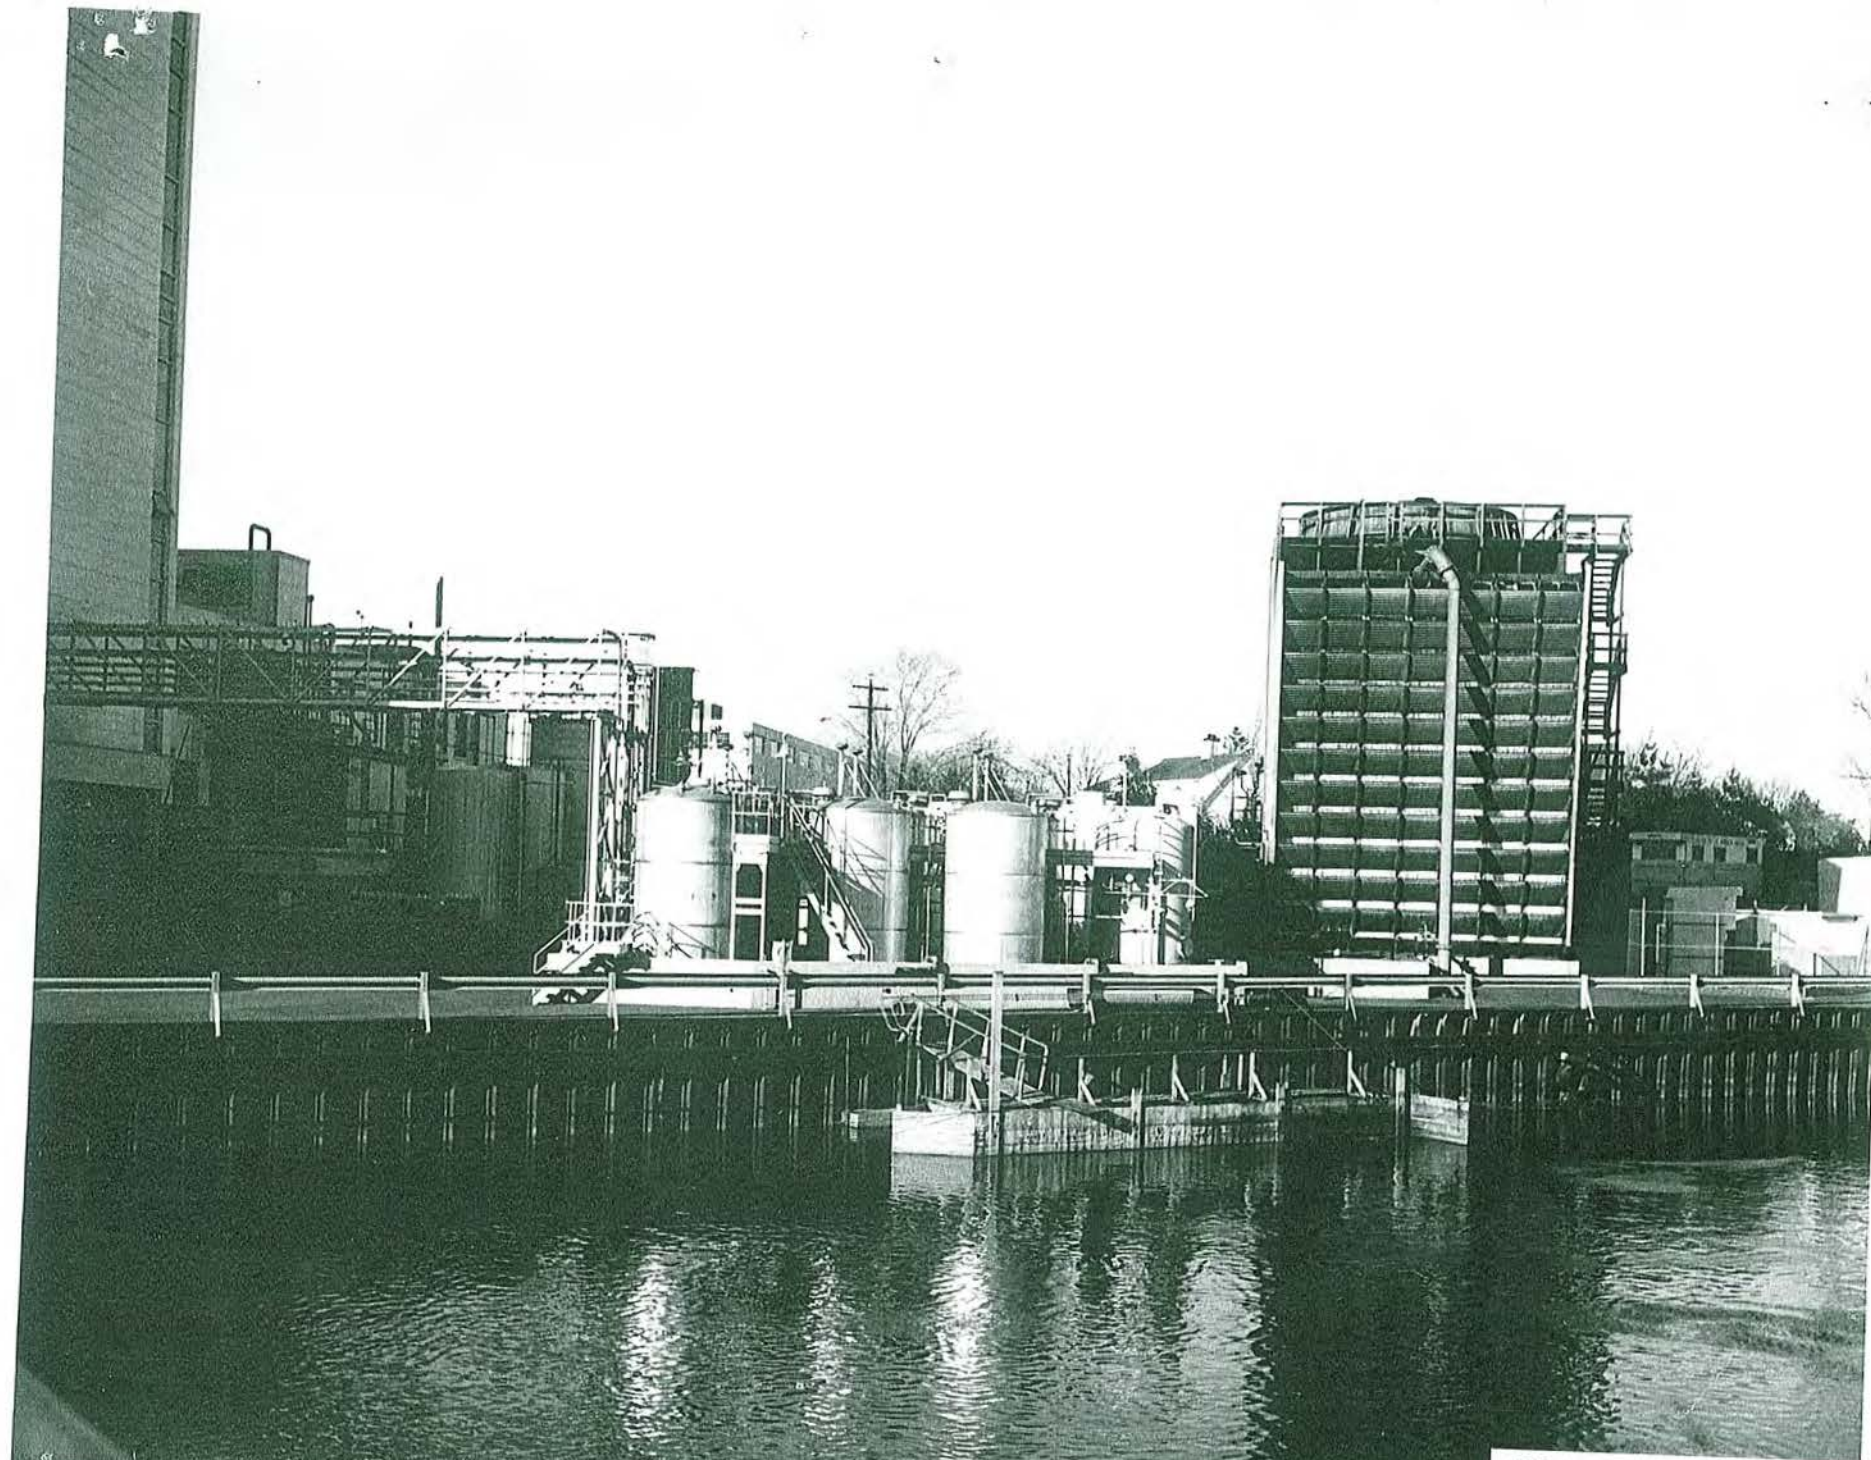
FIGURE 1-2
FORMER COFFERDAM

Prior to 1975, wastewater from manufacturing operations were discharged to a cofferdam adjacent to the bulkhead in the Production Area. The cofferdam was a baffled wooden solvent recovery structure which provided residence time for the wastewater and allowed for free phase solvents to float to the surface and be collected by a skimmer. The cofferdam was approximately 8 feet wide by 50 feet long and was located adjacent to the Production Area bulkhead as shown Figure 1-2. It was taken out of service and decommissioned after Ciba's on-site wastewater treatment plant was put into service in 1975.

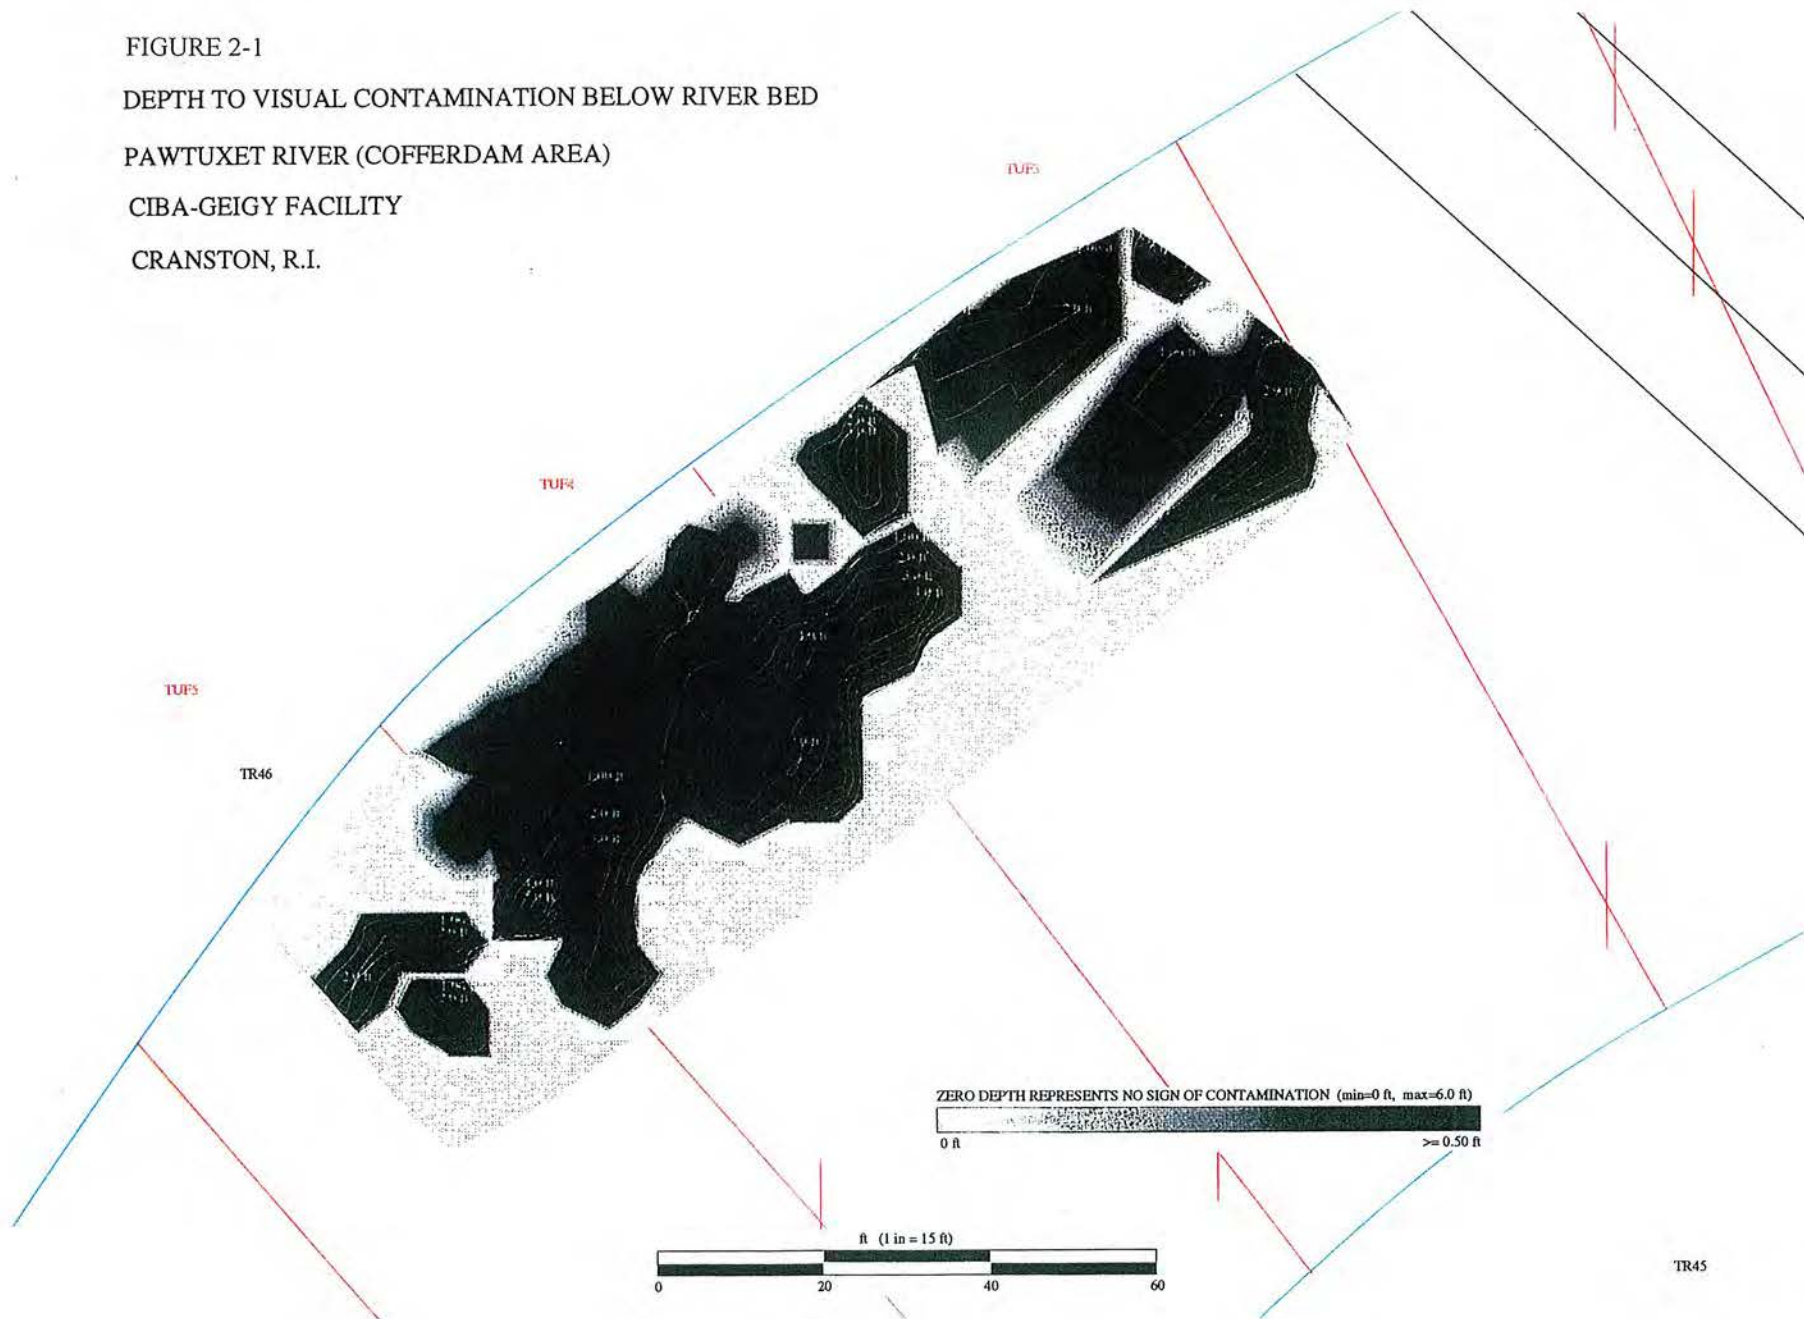
- SD-1A (1-2) SEDIMENT SAMPLING LOCATION (SAMPLE DEPTH, FT.)
- SD-1A ⊕ SEDIMENT SAMPLING LOCATIONS WHERE VISIBLE STAINING WAS OBSERVED
- SD-2B ■ SEDIMENT SAMPLING LOCATIONS WHERE ELEVATED CONCENTRATIONS OF CHLOROBENZENE WERE DETECTED DURING THE RFI
- SD-3A ▲ SEDIMENT SAMPLING LOCATIONS ALONG EDGE OF AREA DELINEATED DURING PROBING STUDY
- BOUNDARY OF VISUAL CONTAMINATION

SAMPLE ID	SAMPLE DEPTH (ft)	DATE / TIME COLLECTED	SAMPLE ANALYSIS	COMMENTS
SD-1A(2-3)	2 - 3	1/19/95 0845	TCLP, Treatability Underlying Haz. Constituents	Old cofferdam area where visible evidence of staining was observed.
SD-1B(1-2)	1 - 2	1/18/95 1045	TCLP, Treatability Underlying Haz. Constituents	Old cofferdam area where visible evidence of staining was observed.
SD-1C(0-1)	0 - 1	1/17/95 1535	TCLP, Treatability Underlying Haz. Constituents	Old cofferdam area where visible evidence of staining was observed.
SD-1D(0-1)	0 - 1	1/19/95 1230	Treatability	Old cofferdam area where visible evidence of staining was observed.
SD-2A(1-2)	1 - 2	1/19/95 0950	TCLP, Treatability Underlying Haz. Constituents	Area shown from previous analyses to have elevated concentrations of chlorobenzene.
SD-2B(0-1)	0 - 1	1/18/95 1450	TCLP, Treatability Underlying Haz. Constituents	Area shown from previous analyses to have elevated concentrations of chlorobenzene.

Underlying Hazardous Constituents were composited from SD-1(A,B,C) and SD-2(A,B,C) for one sample (SD-1-2(A,B,C)) and from SD-3(A,B,C) (SD-3(A,B,C)) for another sample. VOA vials were collected from SD - 1(B+C), SD - 2(B+C) and SD-3(B +C).

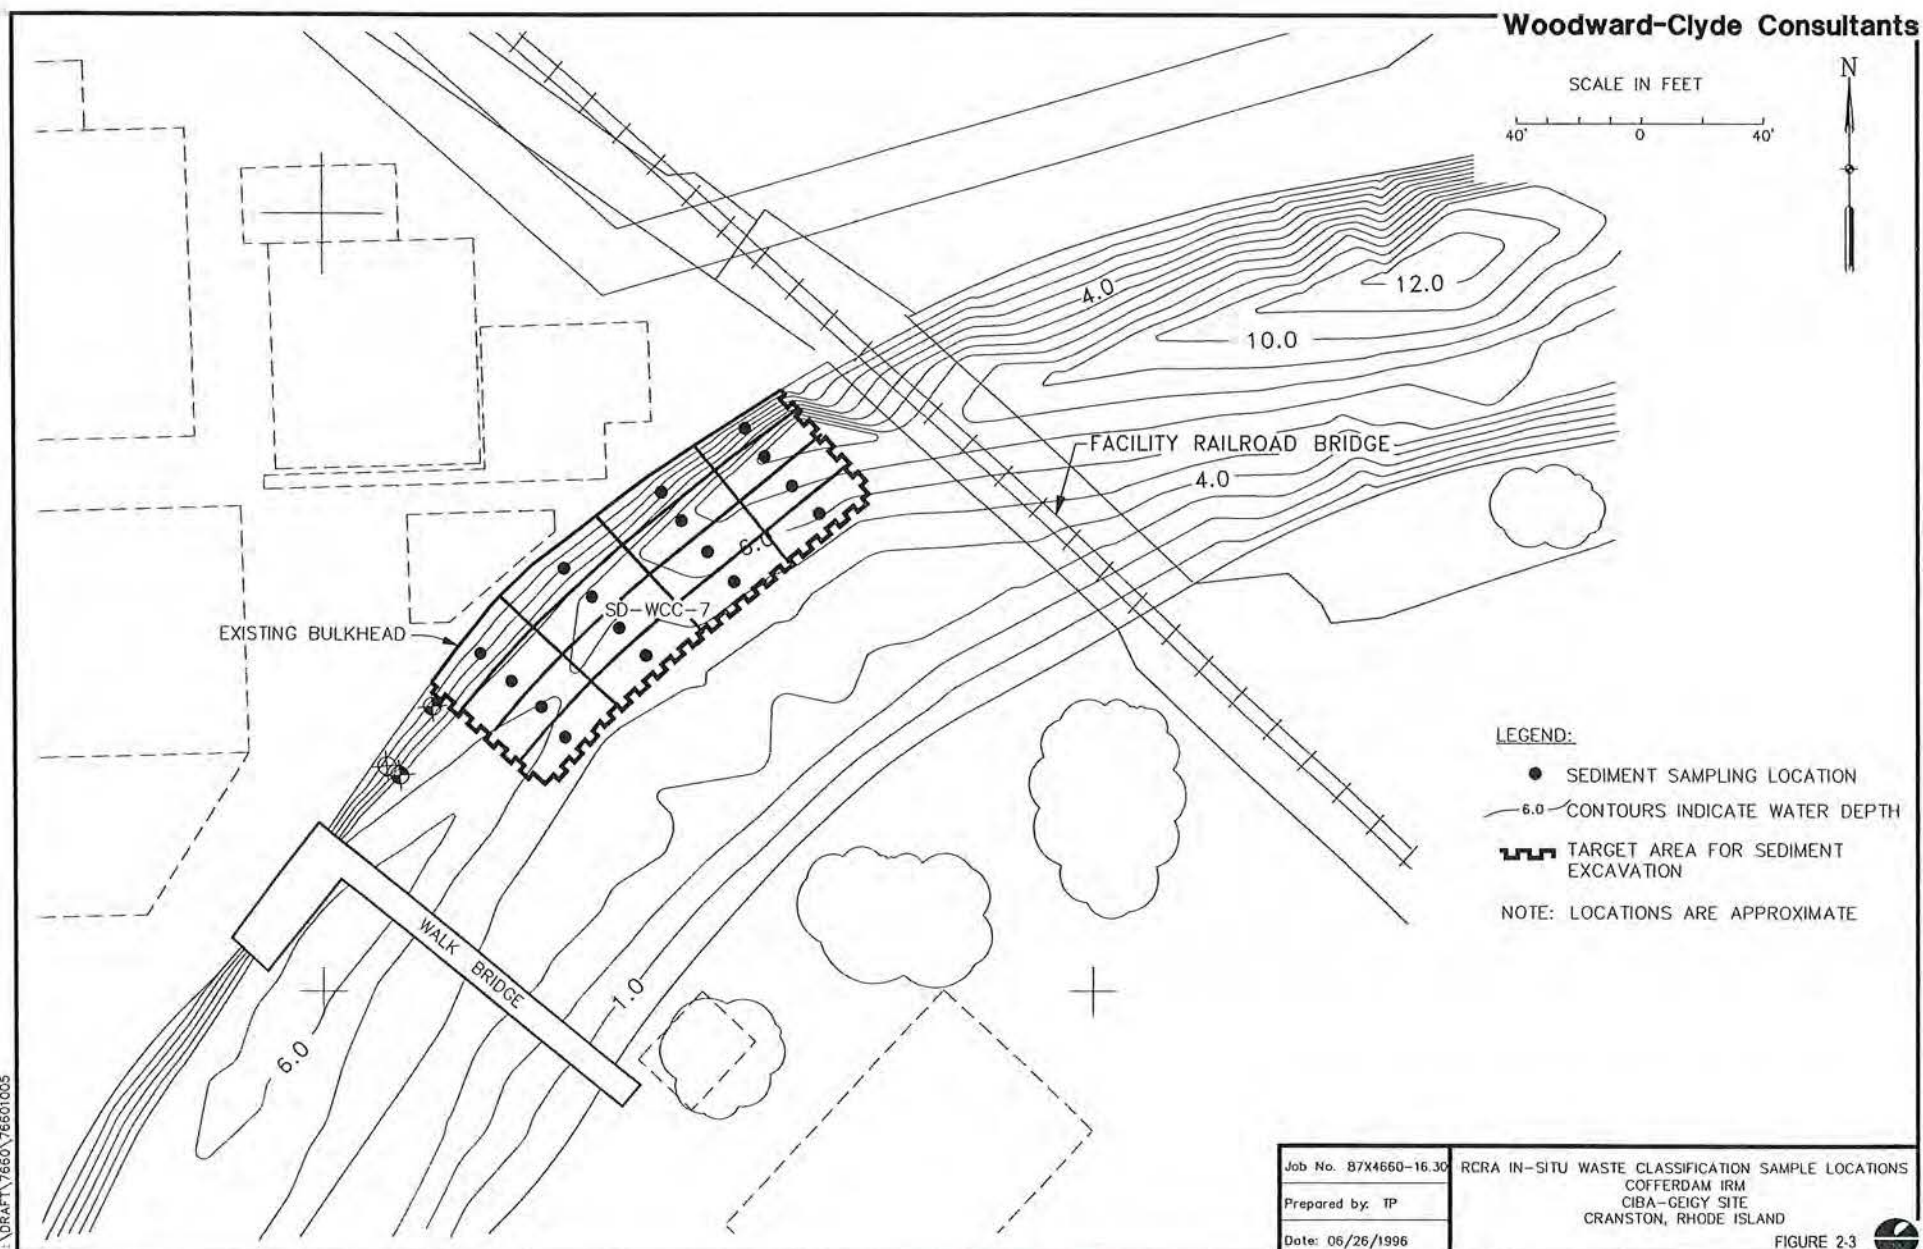
DR. BY	FWD	SCALE	1" = 40'	DWG. NO.	74680113	PROJ. NO.	87X4660
CK'D. BY	EMH	DATE	JULY 9, 1998	FIG. NO.	2-2

SEDIMENT SAMPLING LOCATIONS
JANUARY 17-19, 1995
CIBA-GEIGY SITE
CRANSTON, RHODE ISLAND

Following the Sediment Probing Study, Ciba conducted a sampling event to evaluate the nature of the sediment contamination in the Former Cofferdam Area. Between January 17 and 19, 1995 sediment samples were collected from 20 locations in the Pawtuxet River Upper Facility Reach. Representative samples were collected from both the most visually contaminated areas observed and from areas where contamination was not observed during the Sediment Probing Study, as shown on Figure 2-2. These locations were also sampled at various depths to determine the extent of contamination. The samples were analyzed for the full toxicity characteristic leaching procedure (TCLP) parameters, organic pesticides, and PCBs, as described in Table 2-1. Sufficient sediment sample volume was collected for subsequent treatability testing. The treatability testing included filtration, dewatering, and stabilization.

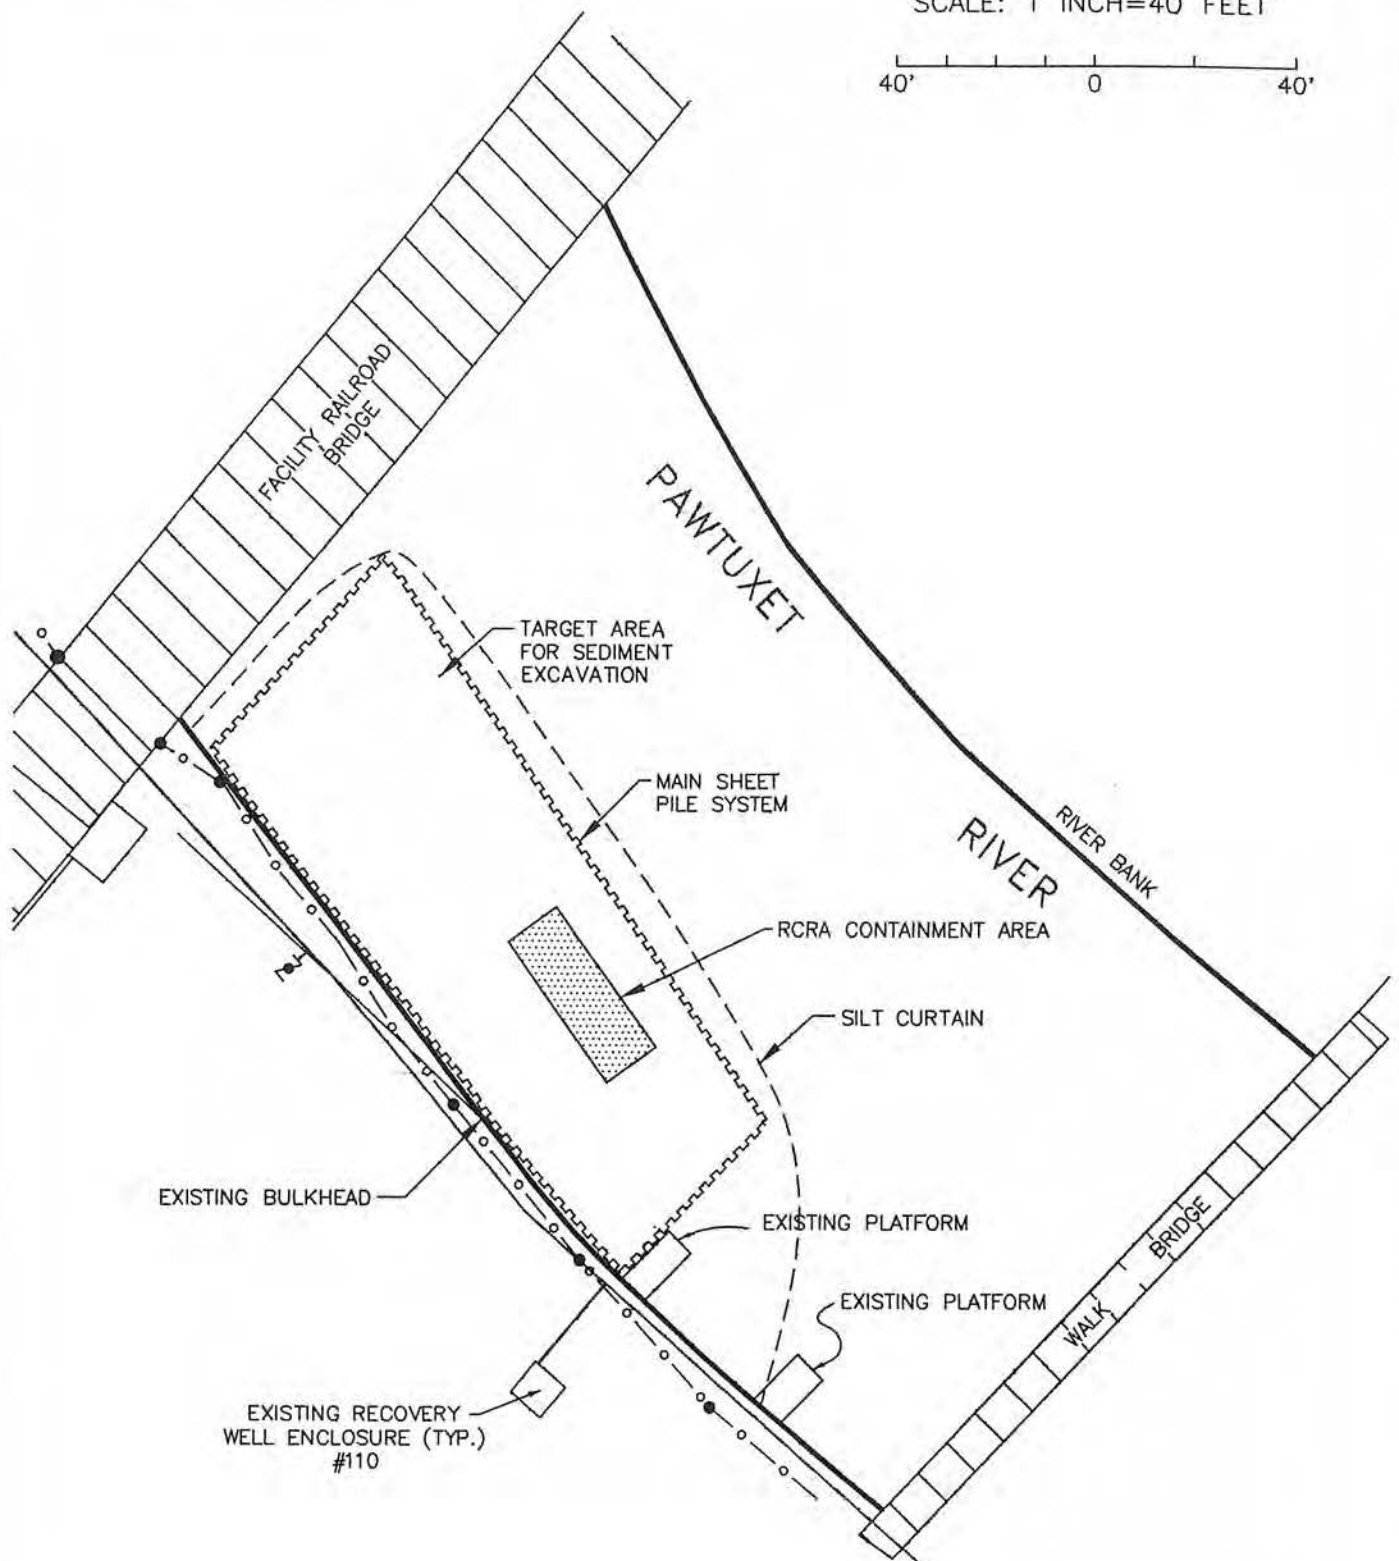
FIGURE 3-2

RCRA CONTAINMENT AREA LOCATION
 COFFERDAM IRM
 CIBA-GEIGY SITE
 CRANSTON, RHODE ISLAND

Prior to excavation, the delineated RCRA containment area had been classified as hazardous due to elevated concentration of chlorobenzene (D021) which exceeded the TCLP regulatory limit of 100 mg/l. The post-excavation TCLP result for chlorobenzene was 4.8 mg/l, well below the regulatory limit. No other VOCs, SVOCs, pesticides or herbicides were detected in this sample. The metals barium, cadmium, lead were detected at 0.54 mg/l, 0.007 mg/l, 0.04 mg/l, respectively.

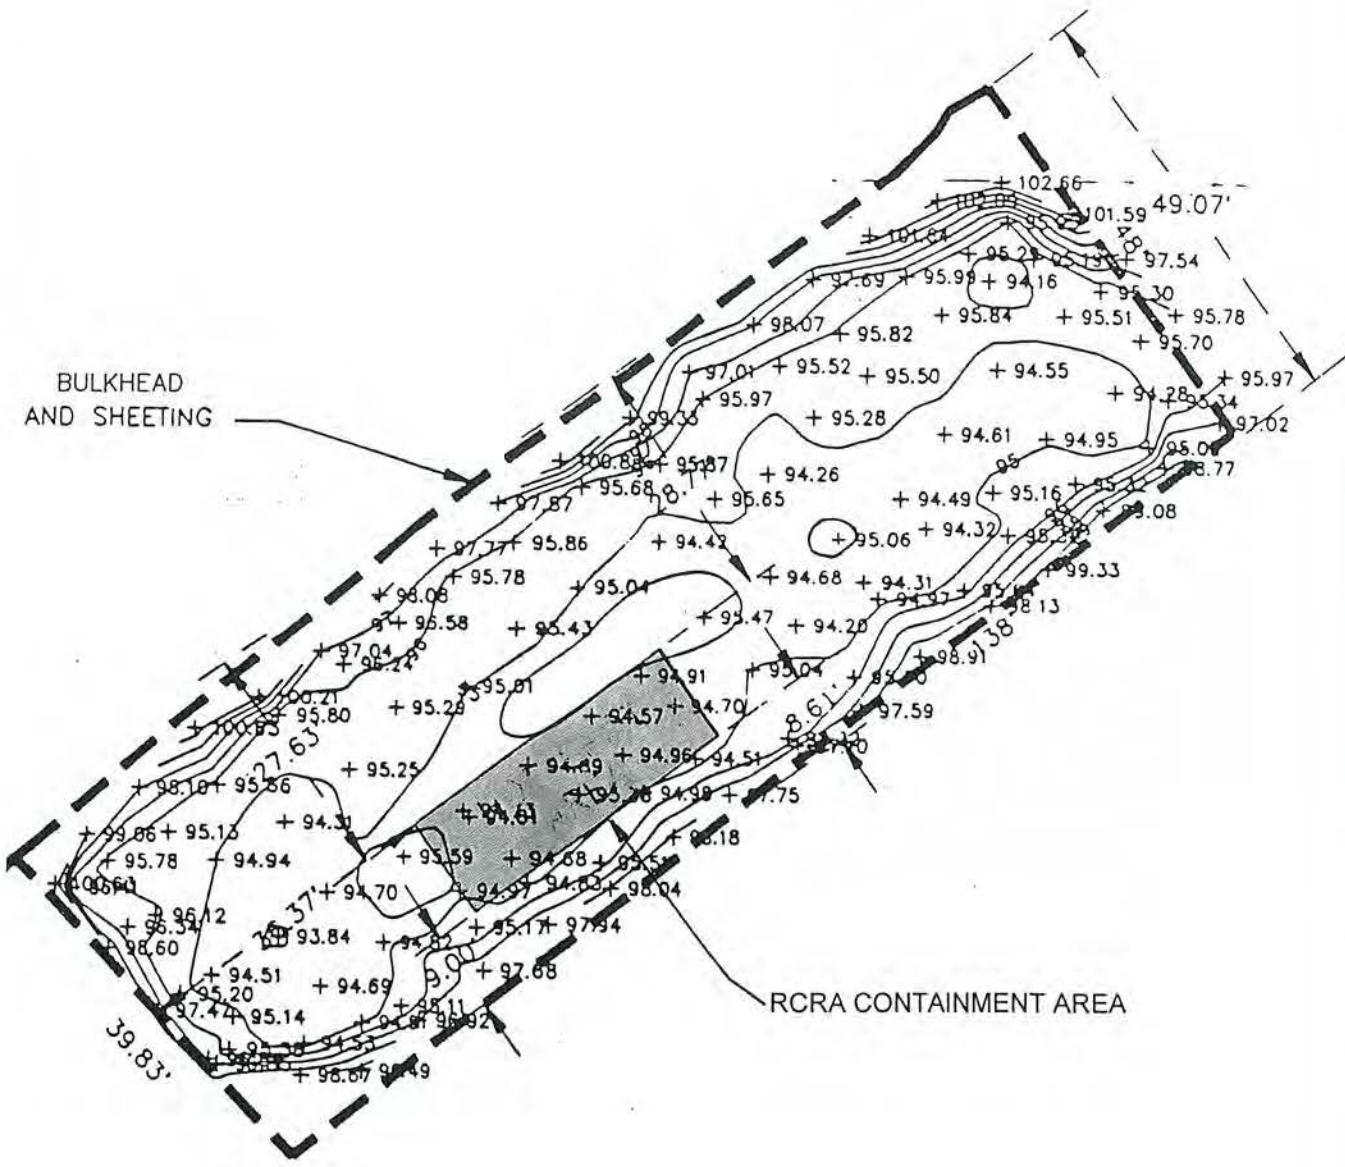
Job No. 86X4660-16.30	TEMPORARY SHEETPILE COFFERDAM POST-EXCAVATION CONTOUR COFFERDAM IRM CIBA-GEIGY SITE CRANSTON, RHODE ISLAND
Prepared by: TP	
Date: 06/26/1996

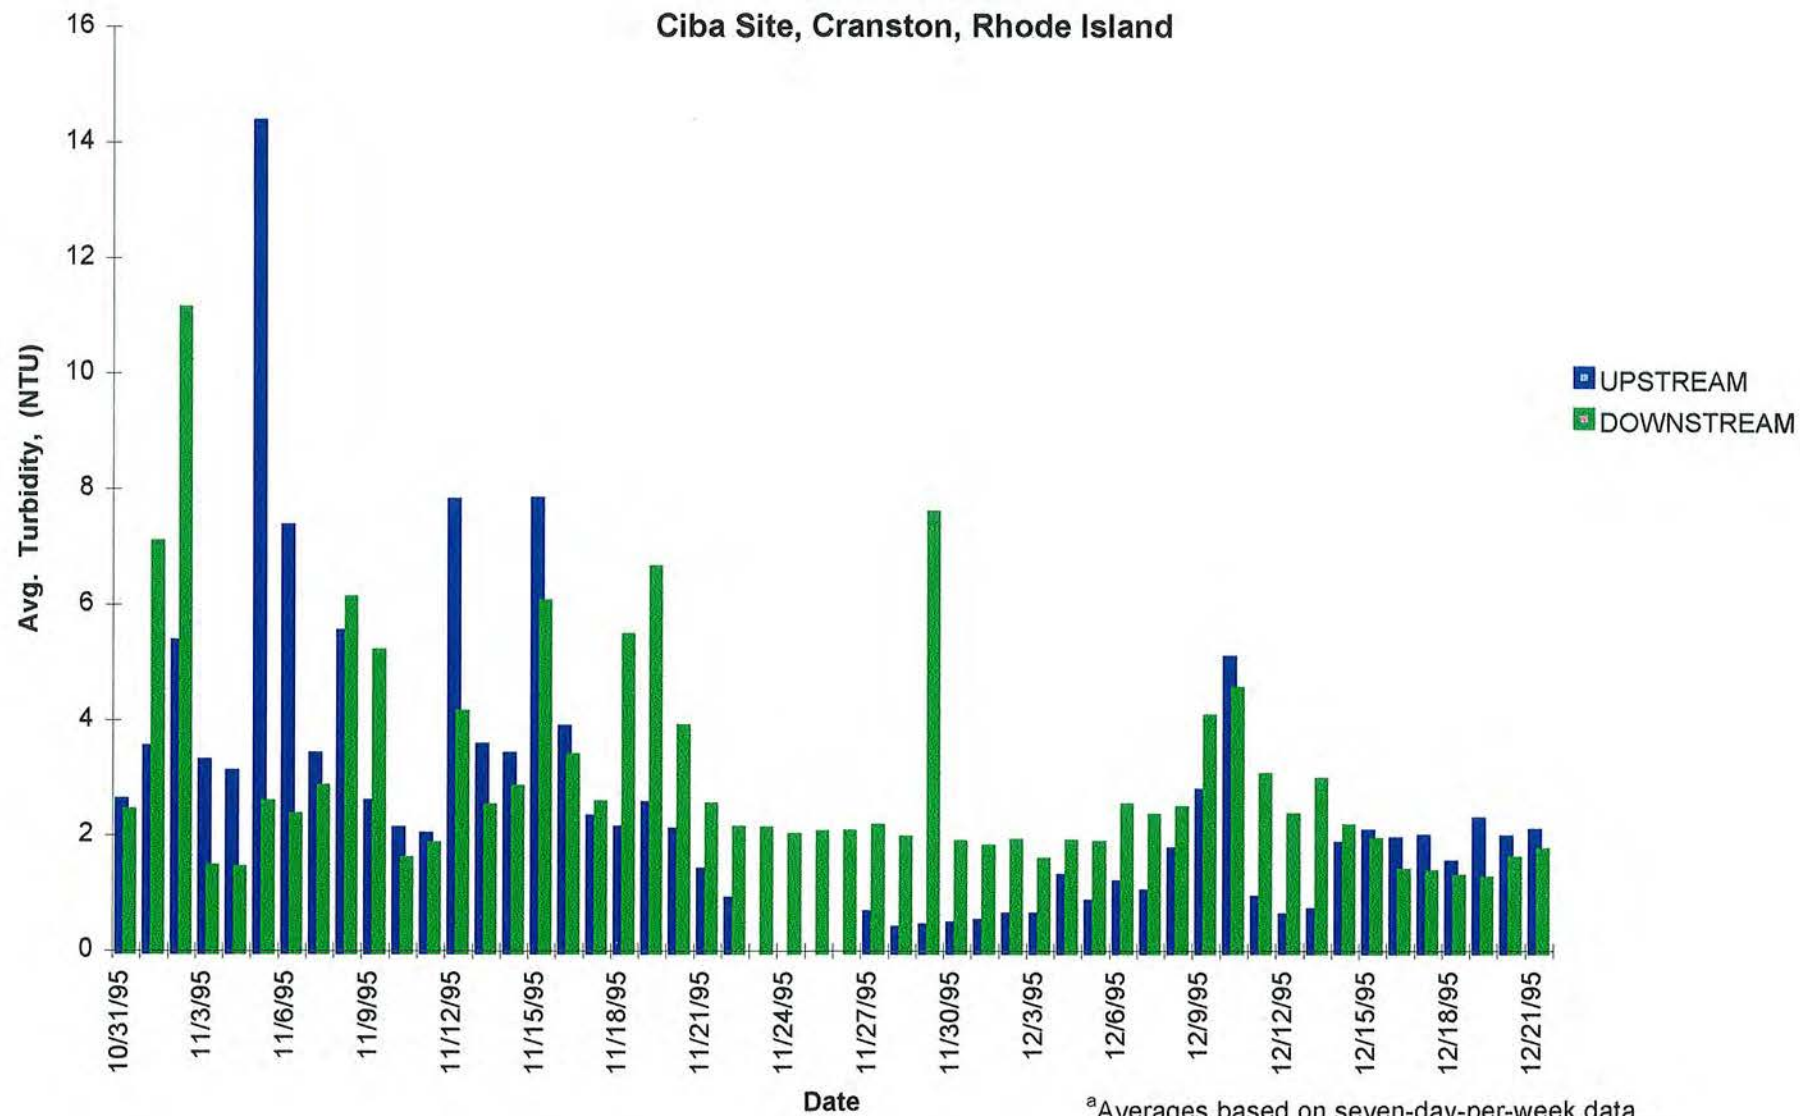
Figure 4-1
Average Daily Turbidity^a
Pawtuxet River
Ciba Site, Cranston, Rhode Island

^aAverages based on seven-day-per-week data

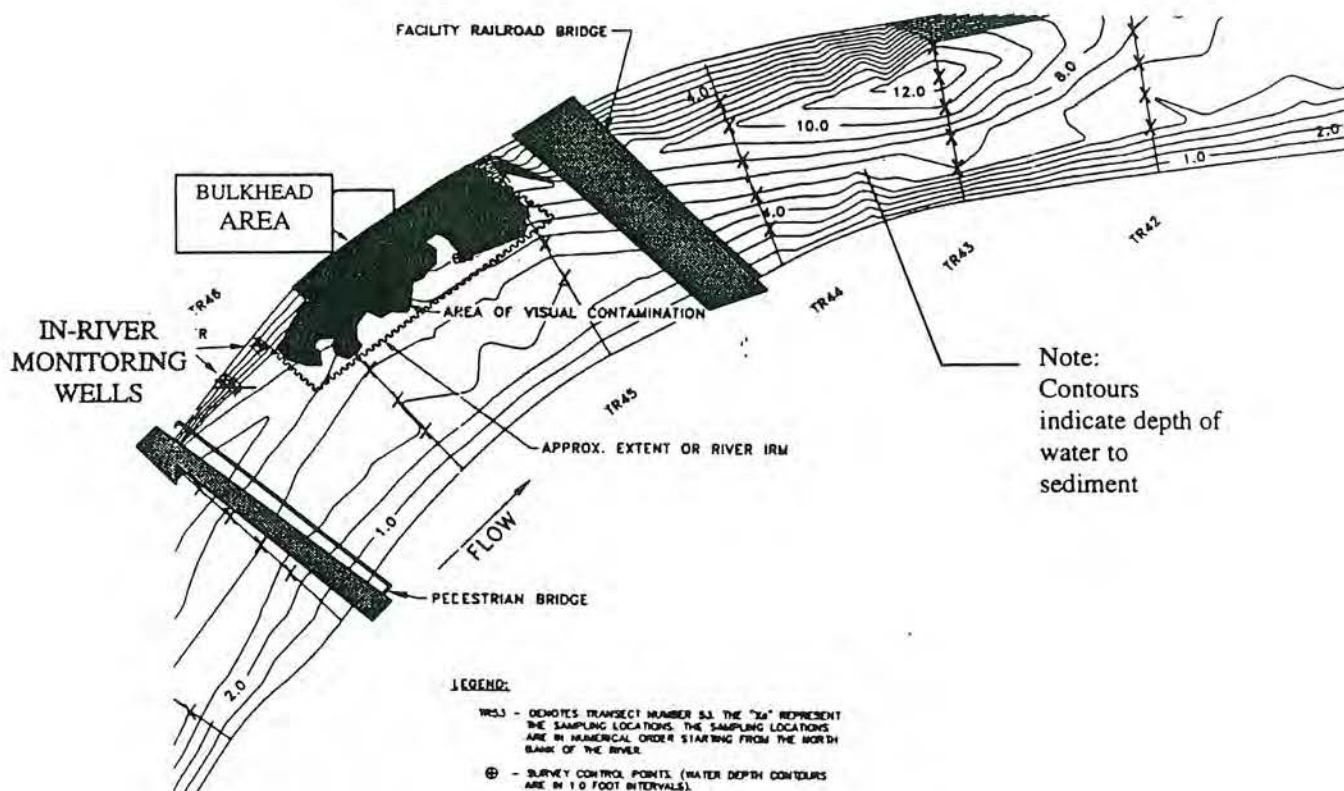
FIGURE 1.3 LOCATION OF VISIBLE CONTAMINATION

The Cofferdam IRM will be implemented by the mass removal of visually contaminated River sediments from the area in and around the former Cofferdam. The contaminated sediments will be removed from an approximately 50 feet by 145 feet area of River bed to a depth of 6 feet. The area of visually contaminated River sediment was delineated both horizontally and laterally during the RFI (Figure 1.3).

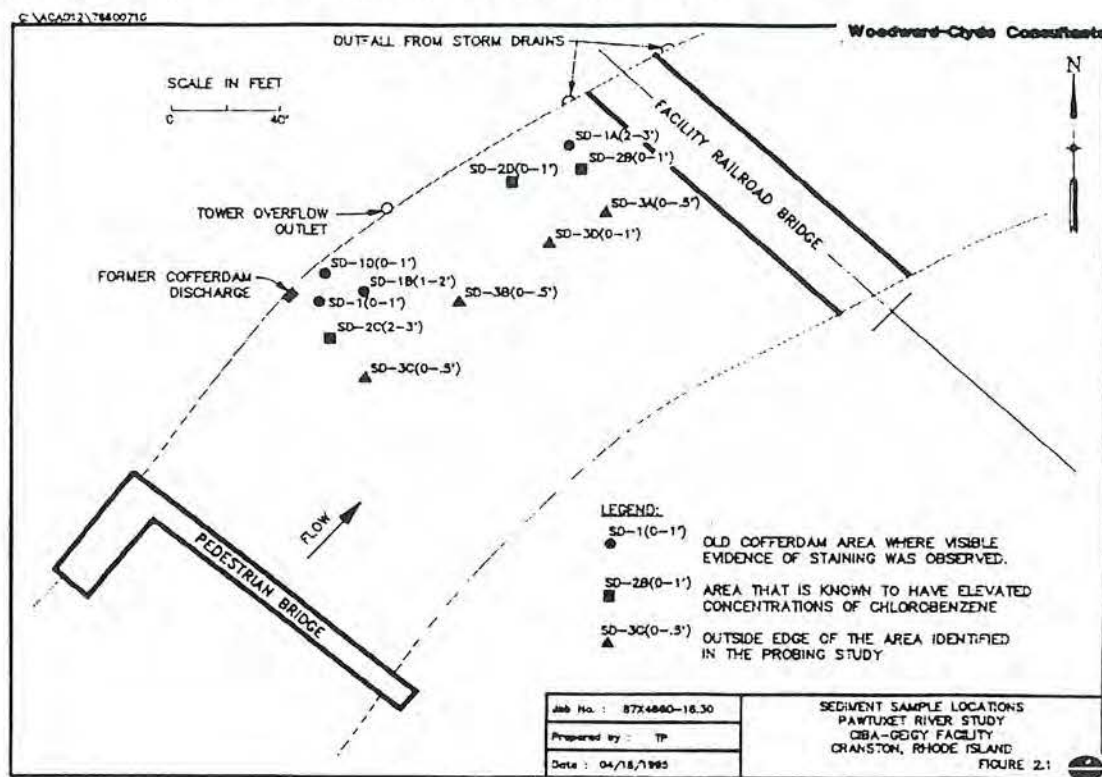
FIGURE 2.1 SAMPLE LOCATIONS IN THE COFFERDAM AREA

Several investigations of the current conditions of the River sediments have been performed as part of the RFI. The investigations have been used to determine the extent of the visual contamination within the former Cofferdam area and the physical and chemical characteristics of the sediment. These data show that the visually-impacted sediments contain contamination that represents discharges from past plant operations. However, samples of these sediments for RCRA waste classification indicate that the sediment to be removed is not RCRA hazardous, on the basis of current TCLP protocols (Table 2.2).

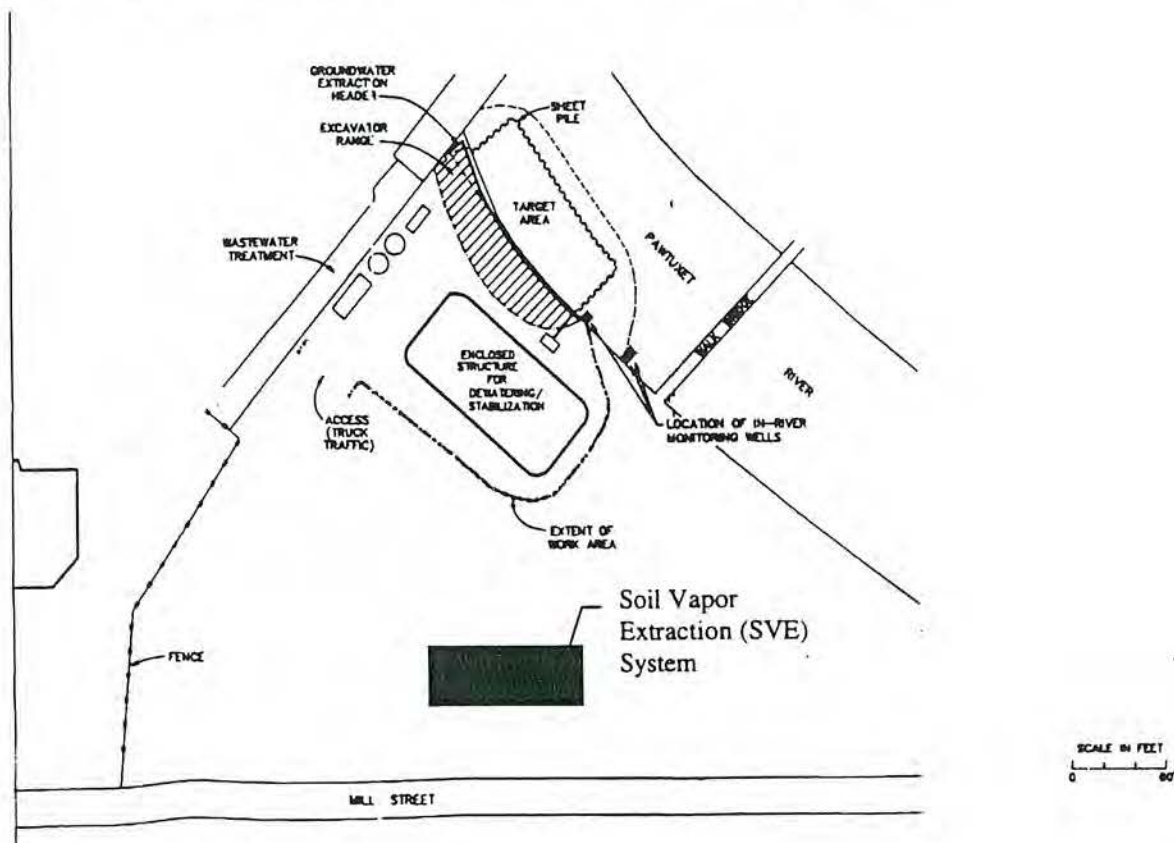
FIGURE 5.1 GENERALIZED LAYOUT OF THE COFFERDAM IRM

The Cofferdam IRM will be developed on the basis of a performance specification. It will be the contractors responsibility to design each component necessary to complete the project. The design and components of the Cofferdam IRM will be in compliance with all applicable laws and regulations. The IRM design will also be technically and economically feasible, as well as protective of human health and the environment. A conceptual depiction of the generalized IRM layout is shown in Figure 5.1.

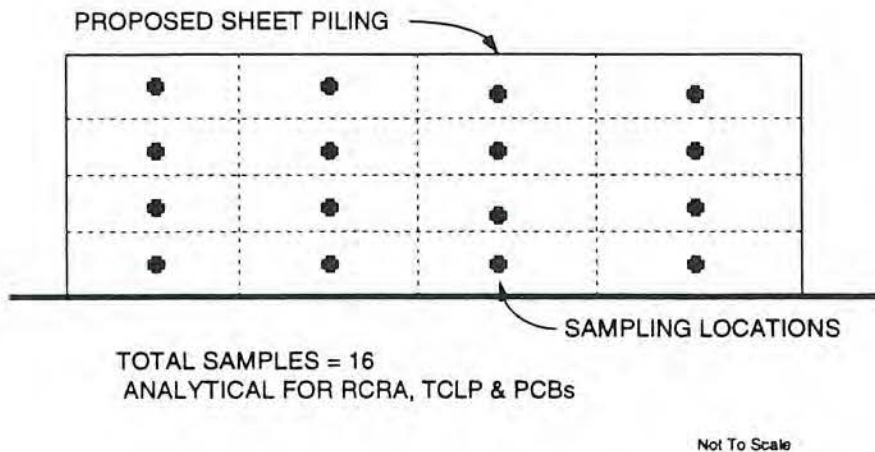
FIGURE 5.2 WASTE CHARACTERIZATION SAMPLING

Waste classification samples will be collected and analyzed before the start of sediment removal activities. Proposed waste classification composite sampling locations are shown in Figure 5.2. These proposed sampling locations may change based on actual conditions encountered in the field. The sampling scheme will be as follows:

- One sample representative of approximately 100 cubic yards;
- Samples from the Cofferdam area will be collected from 0.5 to 6.0 feet (or until refusal) below the River bottom because previous studies have suggested that this is the vertical extent of visible contamination;
- All samples will be analyzed for RCRA characteristics, TCLP and total PCBs.
